Photo Log: <Soldotna Y Chevron>

Date of Inspection: 6/16/2014

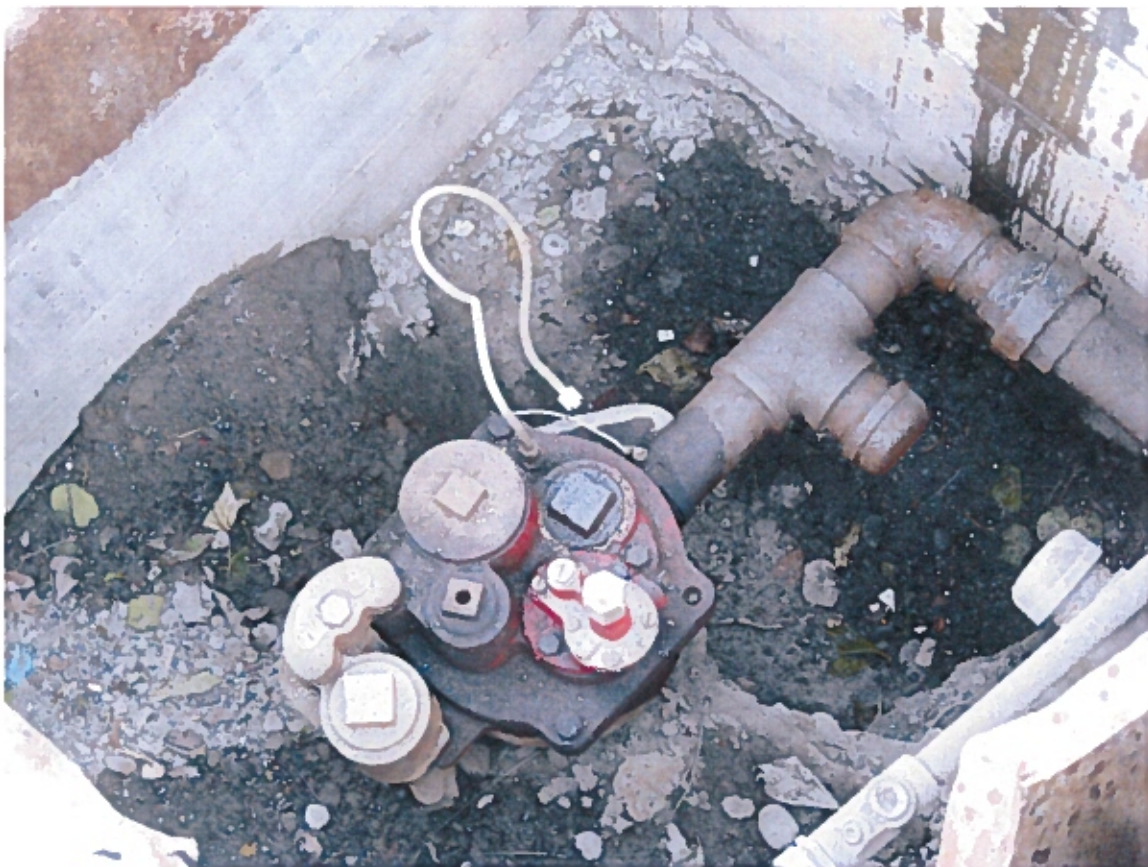
Figure 027.jpg: Turbine Sump for tank 4. Leak detector is missing and the pipe that was capped and left in place is visible.

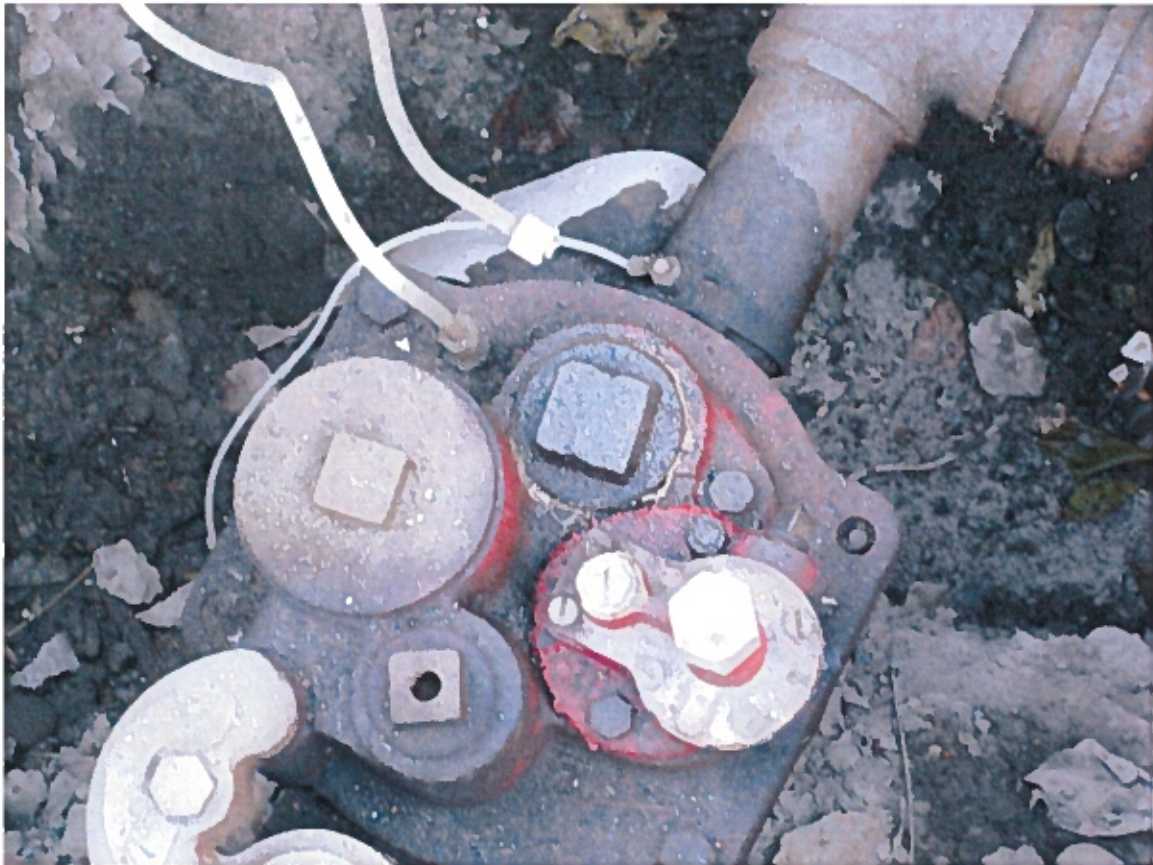
Figure 028.jpg: Turbine Sump for tank 4. Leak detector is not present
